Contract #: 04-0120F4Cty: SF/ALA Rte: 80 PM: 13.2/13.9File #: 1.28**WELDING INSPECTION REPORT****Resident Engineer:**Siegenthaler, Peter**Address:** 333 Burma Road**City:** Oakland, CA 94607**Report No:** WIR-025898**Date Inspected:** 10-Aug-2011**Project Name:** SAS Superstructure**OSM Arrival Time:** 700**Prime Contractor:** American Bridge/Fluor Enterprises, a JV**OSM Departure Time:** 1530**Contractor:** American Bridge/Fluor Enterprises, a JV**Location:** Job Site

Bridge No: 34-0006**Component:** SAS Tower**Summary of Items Observed:**

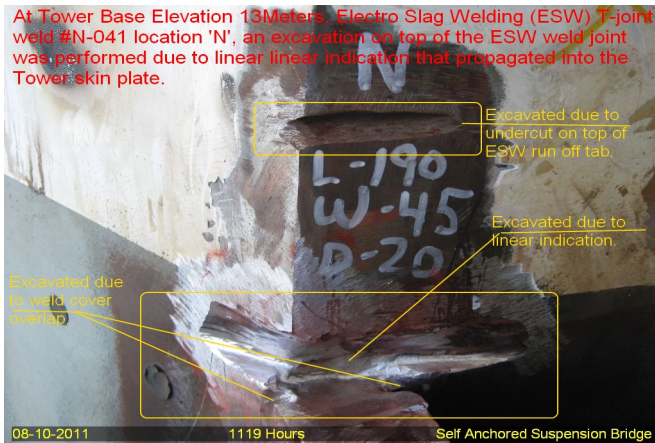
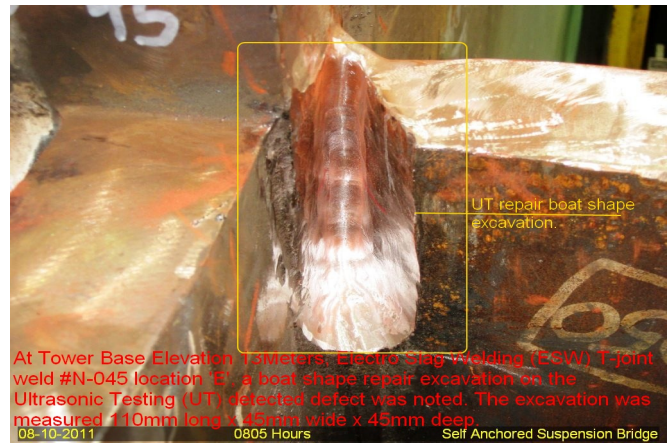
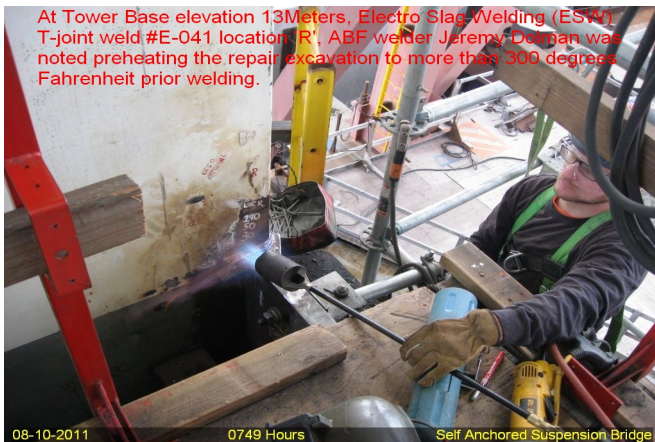
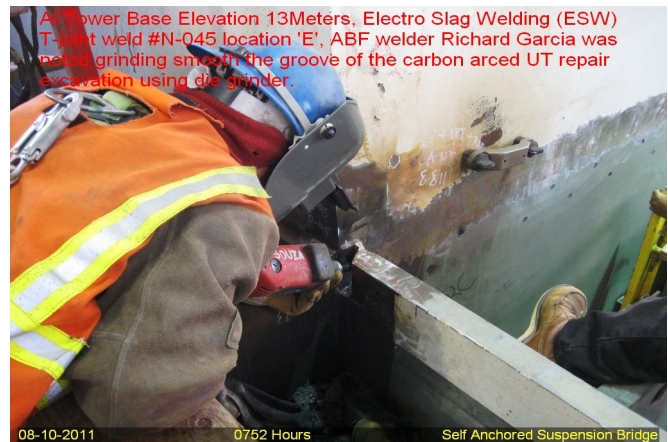
At Tower Base Elevation 13Meters, Electro Slag Welding (ESW) T-joint E-041 location 'R', QA randomly observed ABF/JV qualified welder Jeremy Dolman continuing to perform CJP groove welding repair on the top of the welded ESW due to ABF QC noted linear indications that propagated into the Tower skin plate. The top of the ESW weld joint is being repaired with approval through Repair Welding Request (RWR) # 201108-007. The welder was observed welding in the 2G (horizontal) position utilizing Shielded Metal Arc Welding (SMAW) with 1/8" diameter E7018H4R electrode implementing welding procedure ABF-WPS-D15-1000-Repairs. The weld repair was preheated to more than 300 degree Fahrenheit using propylene gas torch prior welding. During the shift, ABF QC John Pagliero was noted monitoring the welder. Measured welding parameter during welding was 110 amperes on a 1/8" diameter E7018H4R electrode. Before the end of the shift, 2G SMAW welding repair on ESW weld joint mentioned above was completed. The welder started carbon air arcing the run off tab he used during welding which he did until the end of the shift.

At Tower Base Elevation 13Meters, Electro Slag Welding (ESW) T-joint N-045 location 'E', QA randomly observed ABF/JV qualified welder Richard Garcia continuing to grind the groove of the excavation using die grinder after carbon air arc gouging. The smooth grinding was completed and the welder had asked ABF QC John Pagliero to check the condition of the excavation. ABF QC John Pagliero performed Visual Test (VT) and Magnetic Particle Testing (MT) on the boat shape excavation with affirmative results. This QA verified the VT

At ESW weld T-joint N-041 location 'N', ABF welder Richard Garcia performed carbon air arc gouging on top of the weld joint due to QC MT detected linear indication that propagated into the Tower skin plate. The welder also carbon arc the overlap that was QC MT detected from top of both sides of the weld cover (4 inches long). After the gouging completion, the welder has ground smooth the groove of the excavated linear indication. The grinding was also completed and the welder had asked for ABF QC John Pagliero to check the condition of the excavation. ABF QC John Pagliero performed Visual Test (VT) and Magnetic Particle Testing (MT) on the boat shape excavation with affirmative results. This QA verified the VT and MT performed by ABF QC with same results. This boat shape repair excavation was measured 190mm long x 45mm wide x 20mm deep.

At around 0900 hours during the shift , Caltrans Engineer Doug Wright verbally approved the repair welding of the UT detected repair excavation at ESW T-joint N-045 location 'E'. ABF welder Richard Garcia moved his welding gears and started preheating the repair excavation using propylene gas torch. After attaining the required preheat of more than 300 degree Fahrenheit, the welder was observed welding in the 3G (vertical) position utilizing Shielded Metal Arc Welding (SMAW) with 1/8" diameter E7018H4R electrode implementing welding procedure ABF-WPS-D15-1000-Repairs. During the shift, ABF QC John Pagliero was noted monitoring the welder. Measured welding parameter during welding was 125 amperes on a 1/8" diameter E7018H4R electrode. Later during the shift, it was learned from QC Bonifacio Daquinag that the weld repair mentioned above was approved though Repair Welding Request (RWR) # 201108-010. At the end of the shift, 3G repair welding was still continuing and should continue tomorrow.
